ORNL-1868

DISASSEMBLY AND POSTOPERATIVE EXAMINATION

OF THE AIRCRAFT REACTOR EXPERIMENT

AIRCRAFT REACTOR ENGINEERING DIVISION
DISASSEMBLY AND POSTOPERATIVE EXAMINATION
OF THE AIRCRAFT REACTOR EXPERIMENT

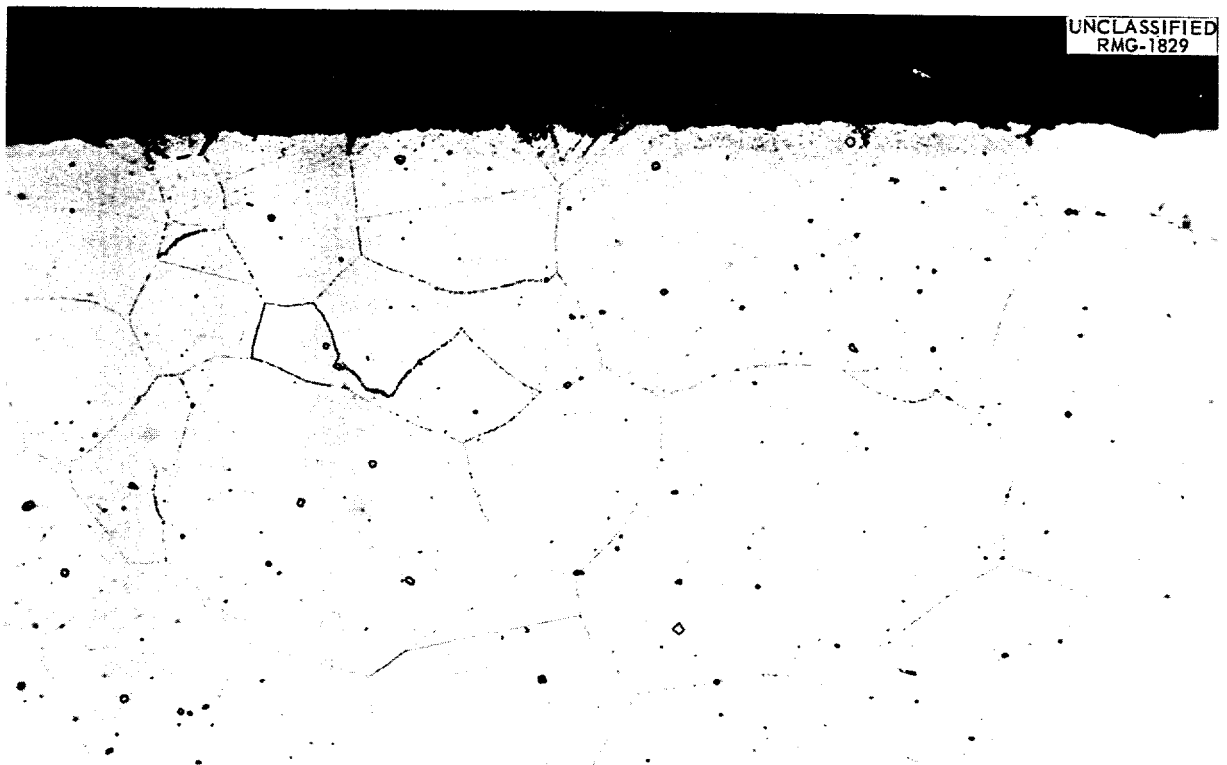
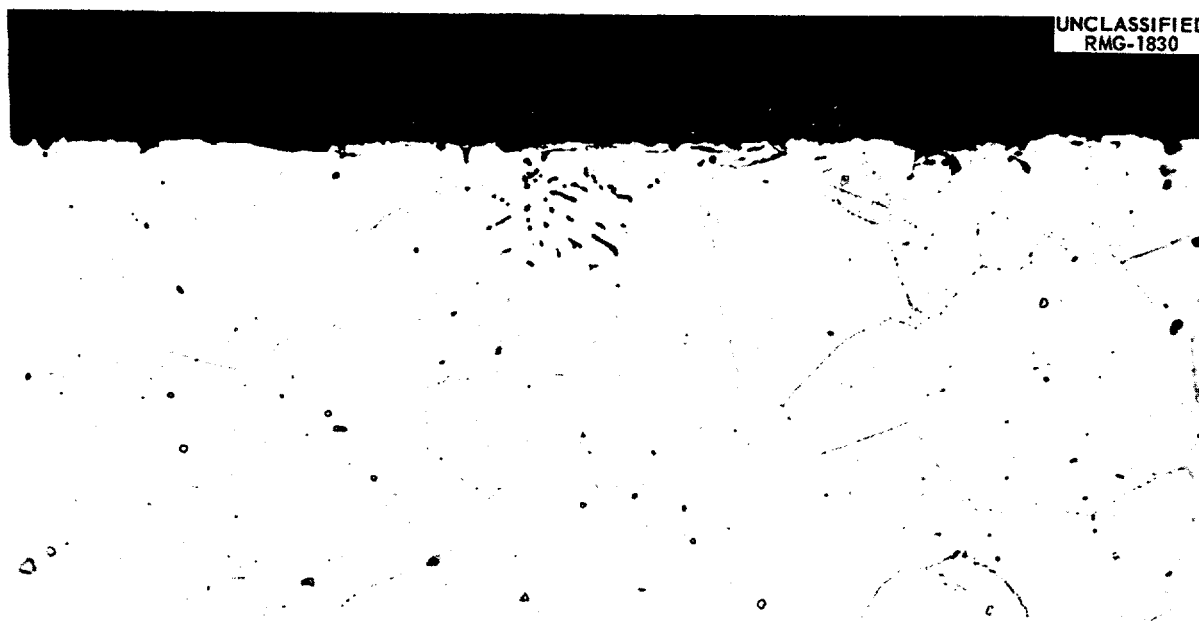
Specimen R3, which was also taken from a serpentine bend in a fuel tube in the center of the core, also showed some subsurface void formation; however, the density and depth of penetration were not so great as for specimen R7. The areas of attack were localized, and some areas of the wall showed no attack, as may be seen in Figs. 35 and 36. No deposit similar to that found on specimen R7 was noted on the exterior wall.

Fig. 35. Section of Specimen R3 Taken from Serpentine Bend in Fuel Tube in ARE Core. Etched. 250X. (See next with caption)

Fig. 36. Another Section of Specimen Shown in Fig. 35. Etched. 250X. (Secret with caption)

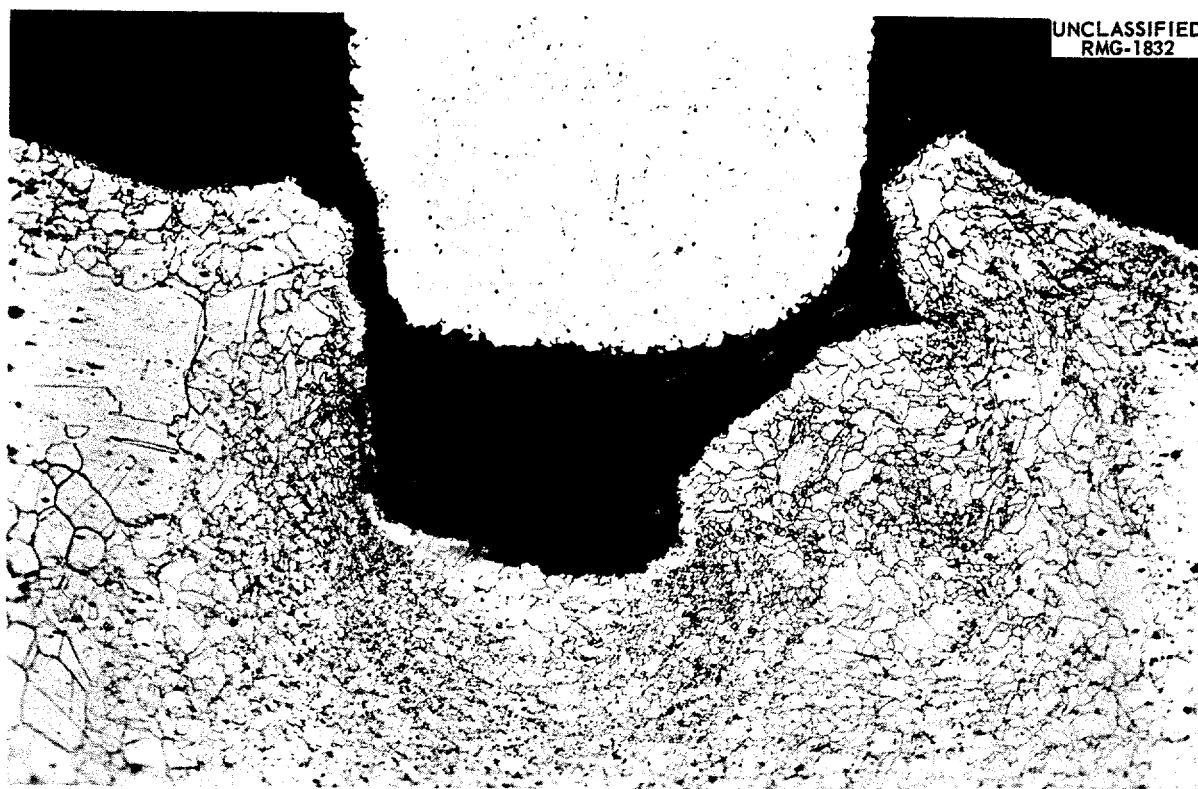
Specimen F5, which was taken from the inlet of a fuel-to-helium heat exchanger, was cast in epoxy resin so that the fins on the tube would not be damaged during cutting. The fin-to-tube wall junction is shown in Fig. 37. (In the ARE fuel-to-helium heat exchangers the fins were helical strips placed in grooves on the tubes. The strips were not brazed to the tubes.) The interior wall of the tube showed subsurface voids to a depth of 4 mils, as shown in Figs. 38 and 39. Specimen F9, which was taken from the middle of a bend in a fuel-to-helium heat exchanger, also showed subsurface voids to a depth of 4 mils, as shown in Figs. 40 and 41. Specimen S6, the bottom bellows from sodium valve U-23, was also cast in epoxy resin. No cracks in the bellows folds were found, and only a slight roughening of the inside surface was noted, as shown in Fig. 42.

Fig. 37. Section of Specimen F5 Showing Fin-to-Tube Wall Junction in ARE Fuel-to-Helium Heat Exchanger. Fins were wound helically in grooves and were not brazed to the tubes. Etched. 100X. (Secret with caption)

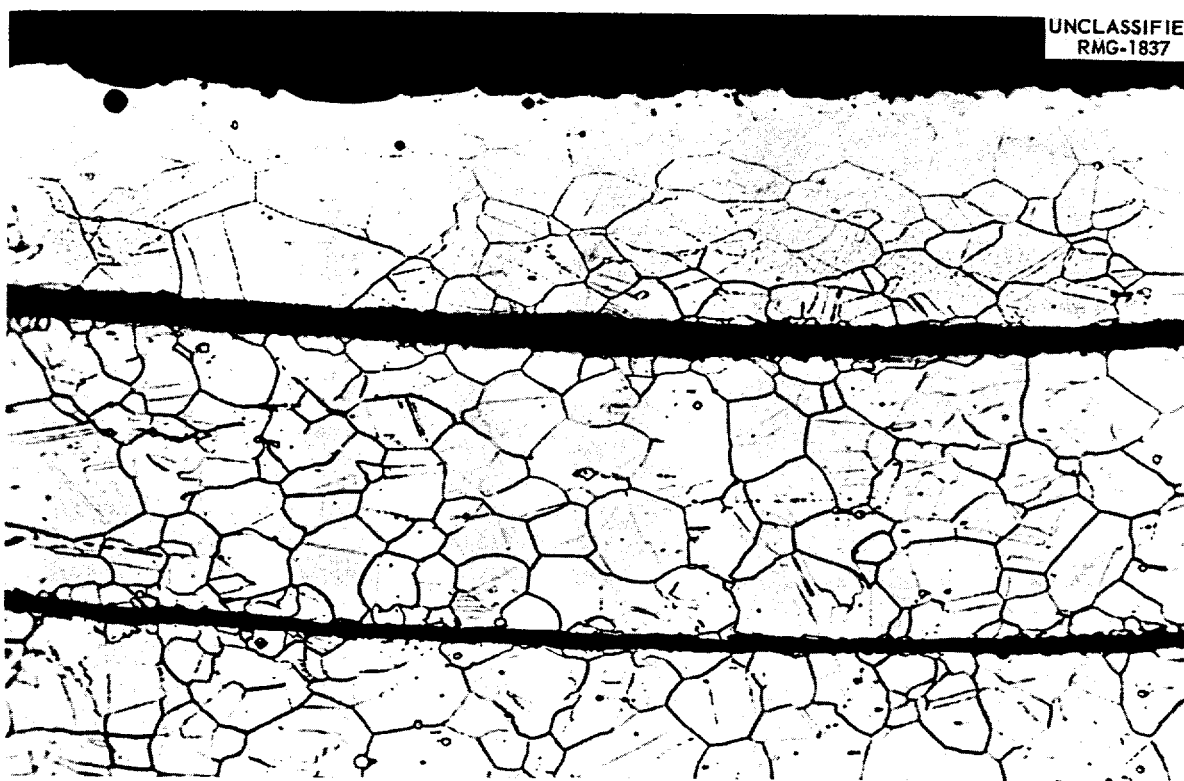
Fig. 42. Section of Specimen S6 Taken from the Bottom Bellows of Sodium Valve U-23. Etched. 250X. (S with caption)

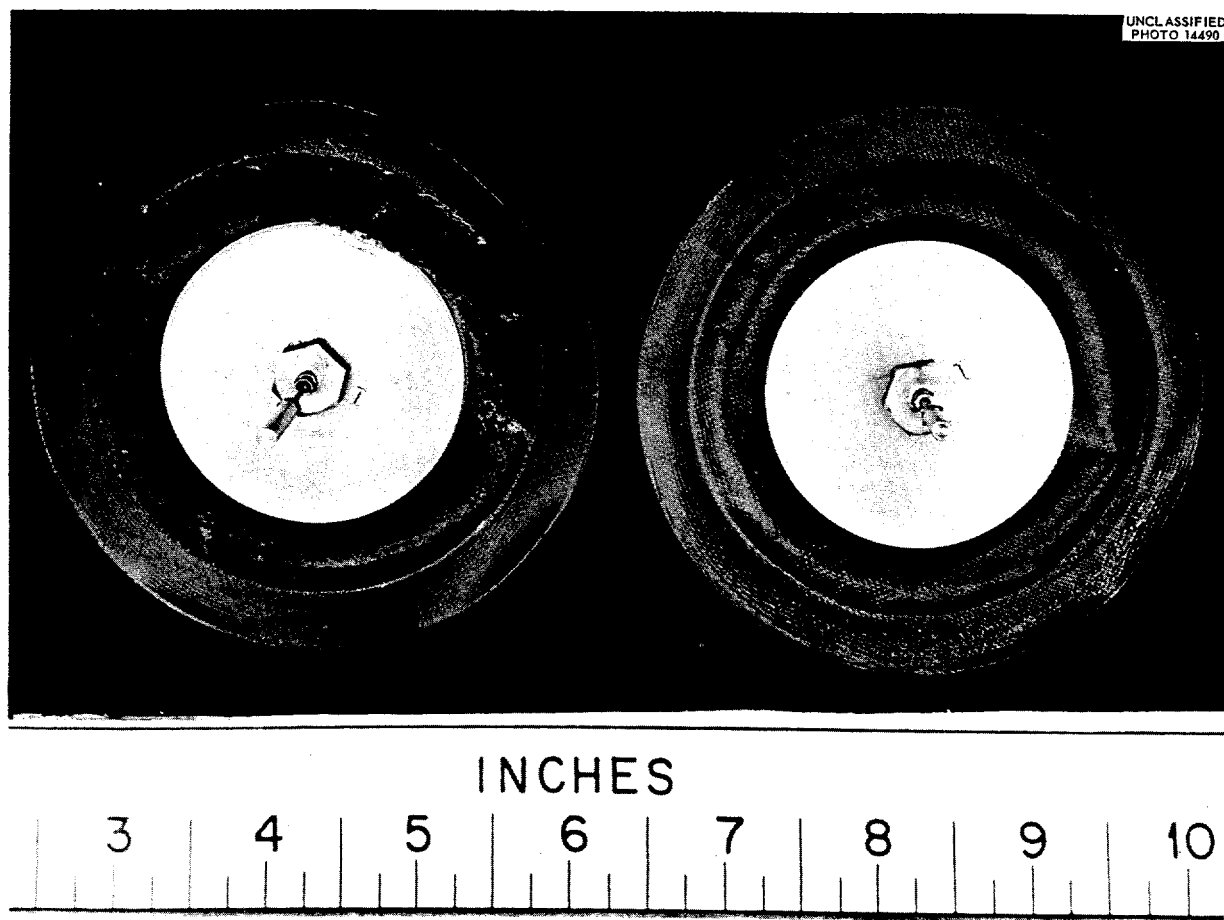
The main and standby fuel pump pressure transmitters (PXT-6 and PXT-7) were examined for calibration shifts, zero shift, radiation damage, and mechanical damage. The standby pump unit was in excellent condition, but the main pump unit was inoperable because of a failure of the glass-cloth pressure-sensing diaphragm, as shown in Fig. 43. Replacement of the diaphragm showed the unit to be otherwise undamaged. The ruptured diaphragm was not the source of the initial fission-gas leak in the ARE, inasmuch as several checks of the unit at the time the heat exchanger pits were closed indicated that the diaphragm was satisfactory. It is believed, however, that the subsequent rupture of the diaphragm was the source of the leak that developed after shutdown of the fuel system. As stated above, the fission-gas leaks that existed prior to shutdown

Fig. 43. Main and Standby Fuel Pump Pressure Transmitter Diaphragms. The ruptured diaphragm was removed from the main fuel pump pressure transmitter.

were probably due to one or more of several potential leaks around the fuel pump.
